DOT HS 806 842

Final Report

September 1984

Side-Impact Aggressiveness Attributes MDB-To-Car Side Impact Test of a 19° Crabbed Moving Deformable Barrier to a 1981 Volkswagen Rabbit at 46.4 Mph

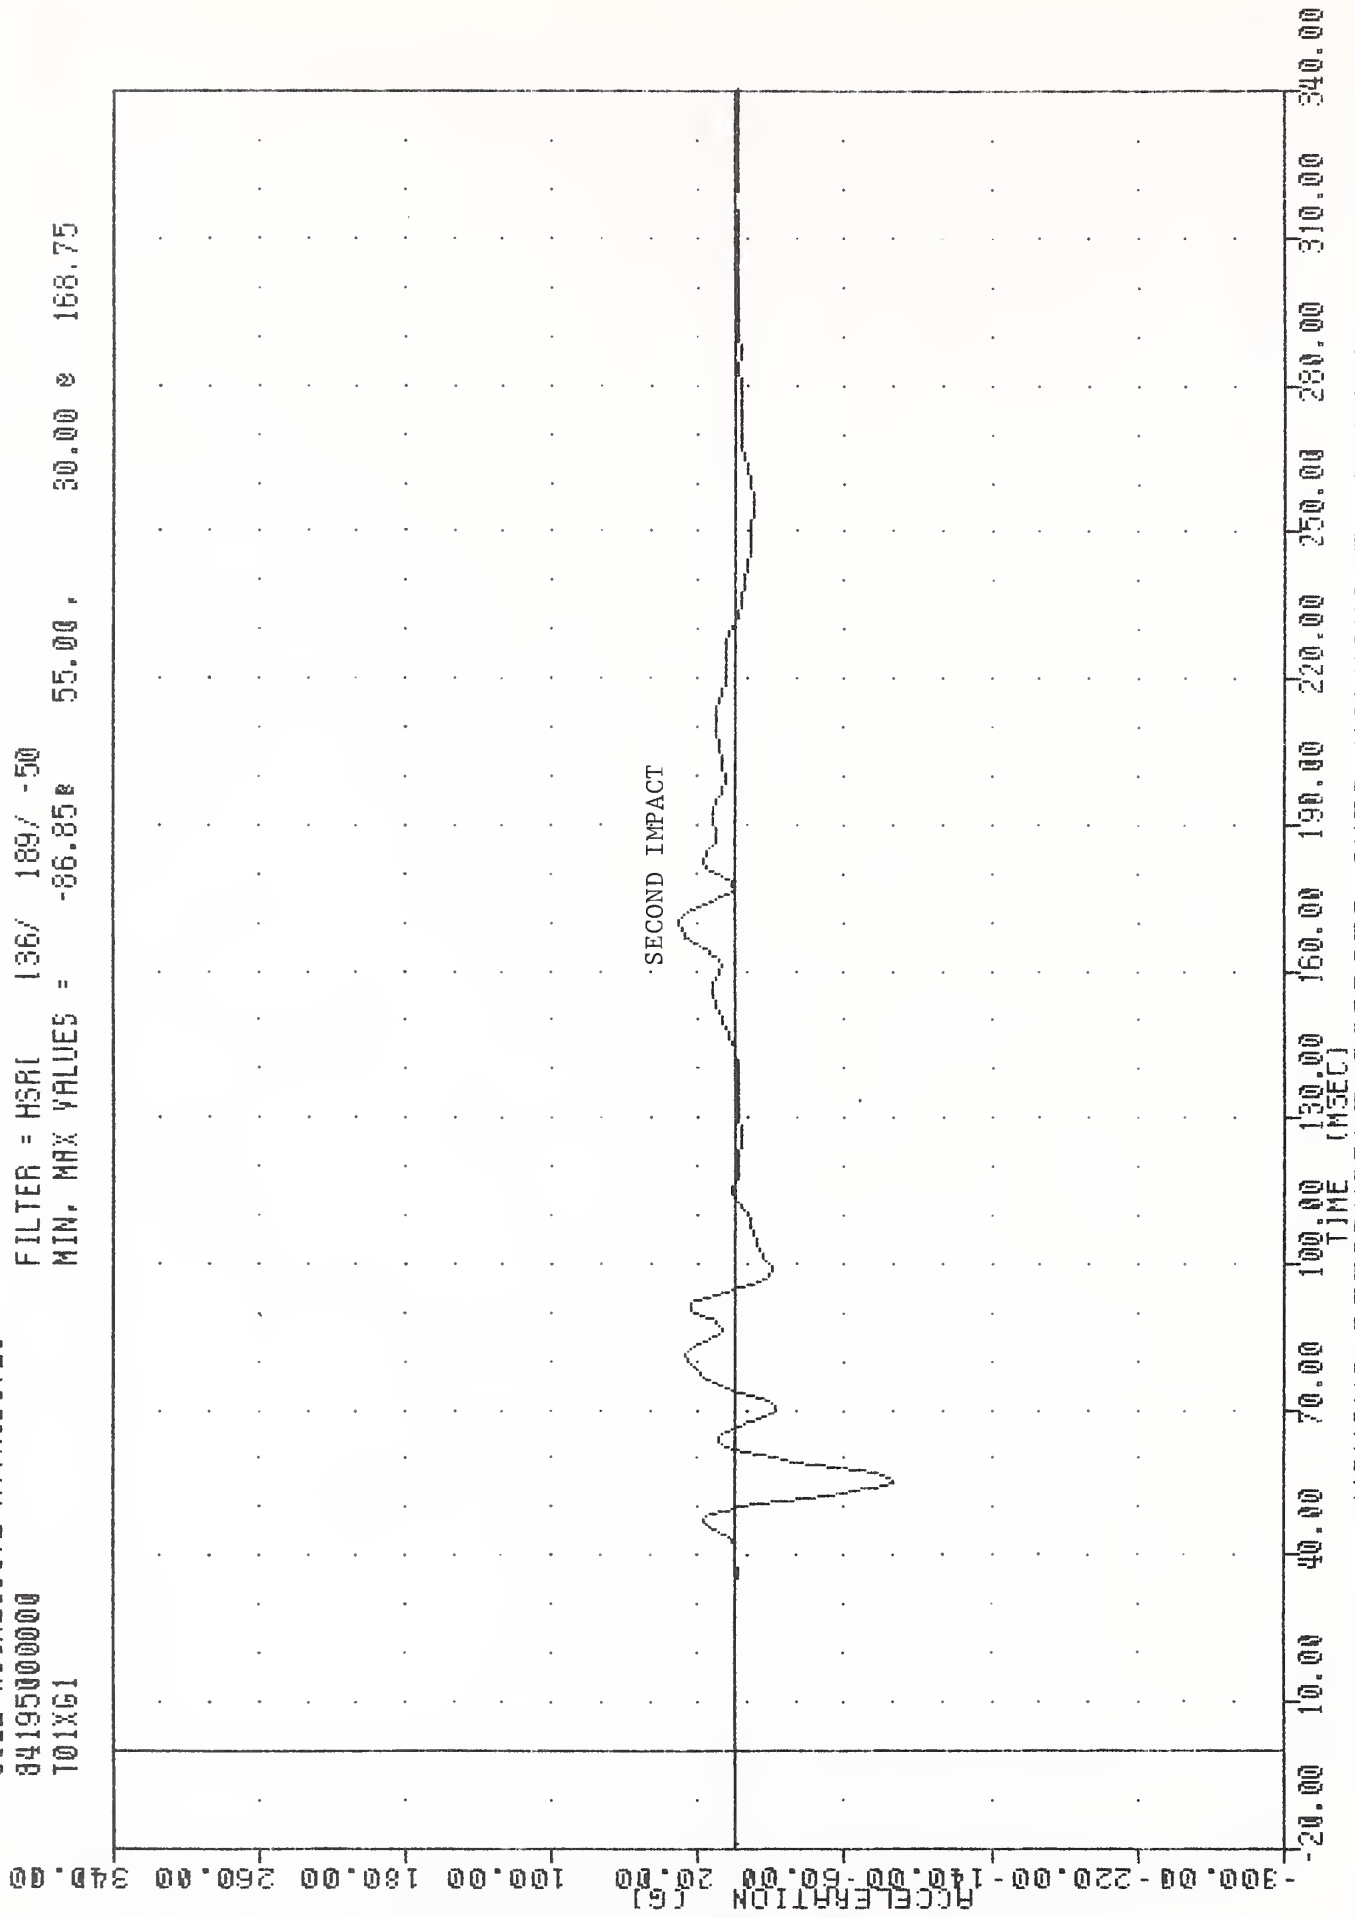
MOVING DEFORMABLE BARRIER INTO VOLKSWAGEN RABBIT
DRIVER UPPER SPINE ACCELERATION X AXIS

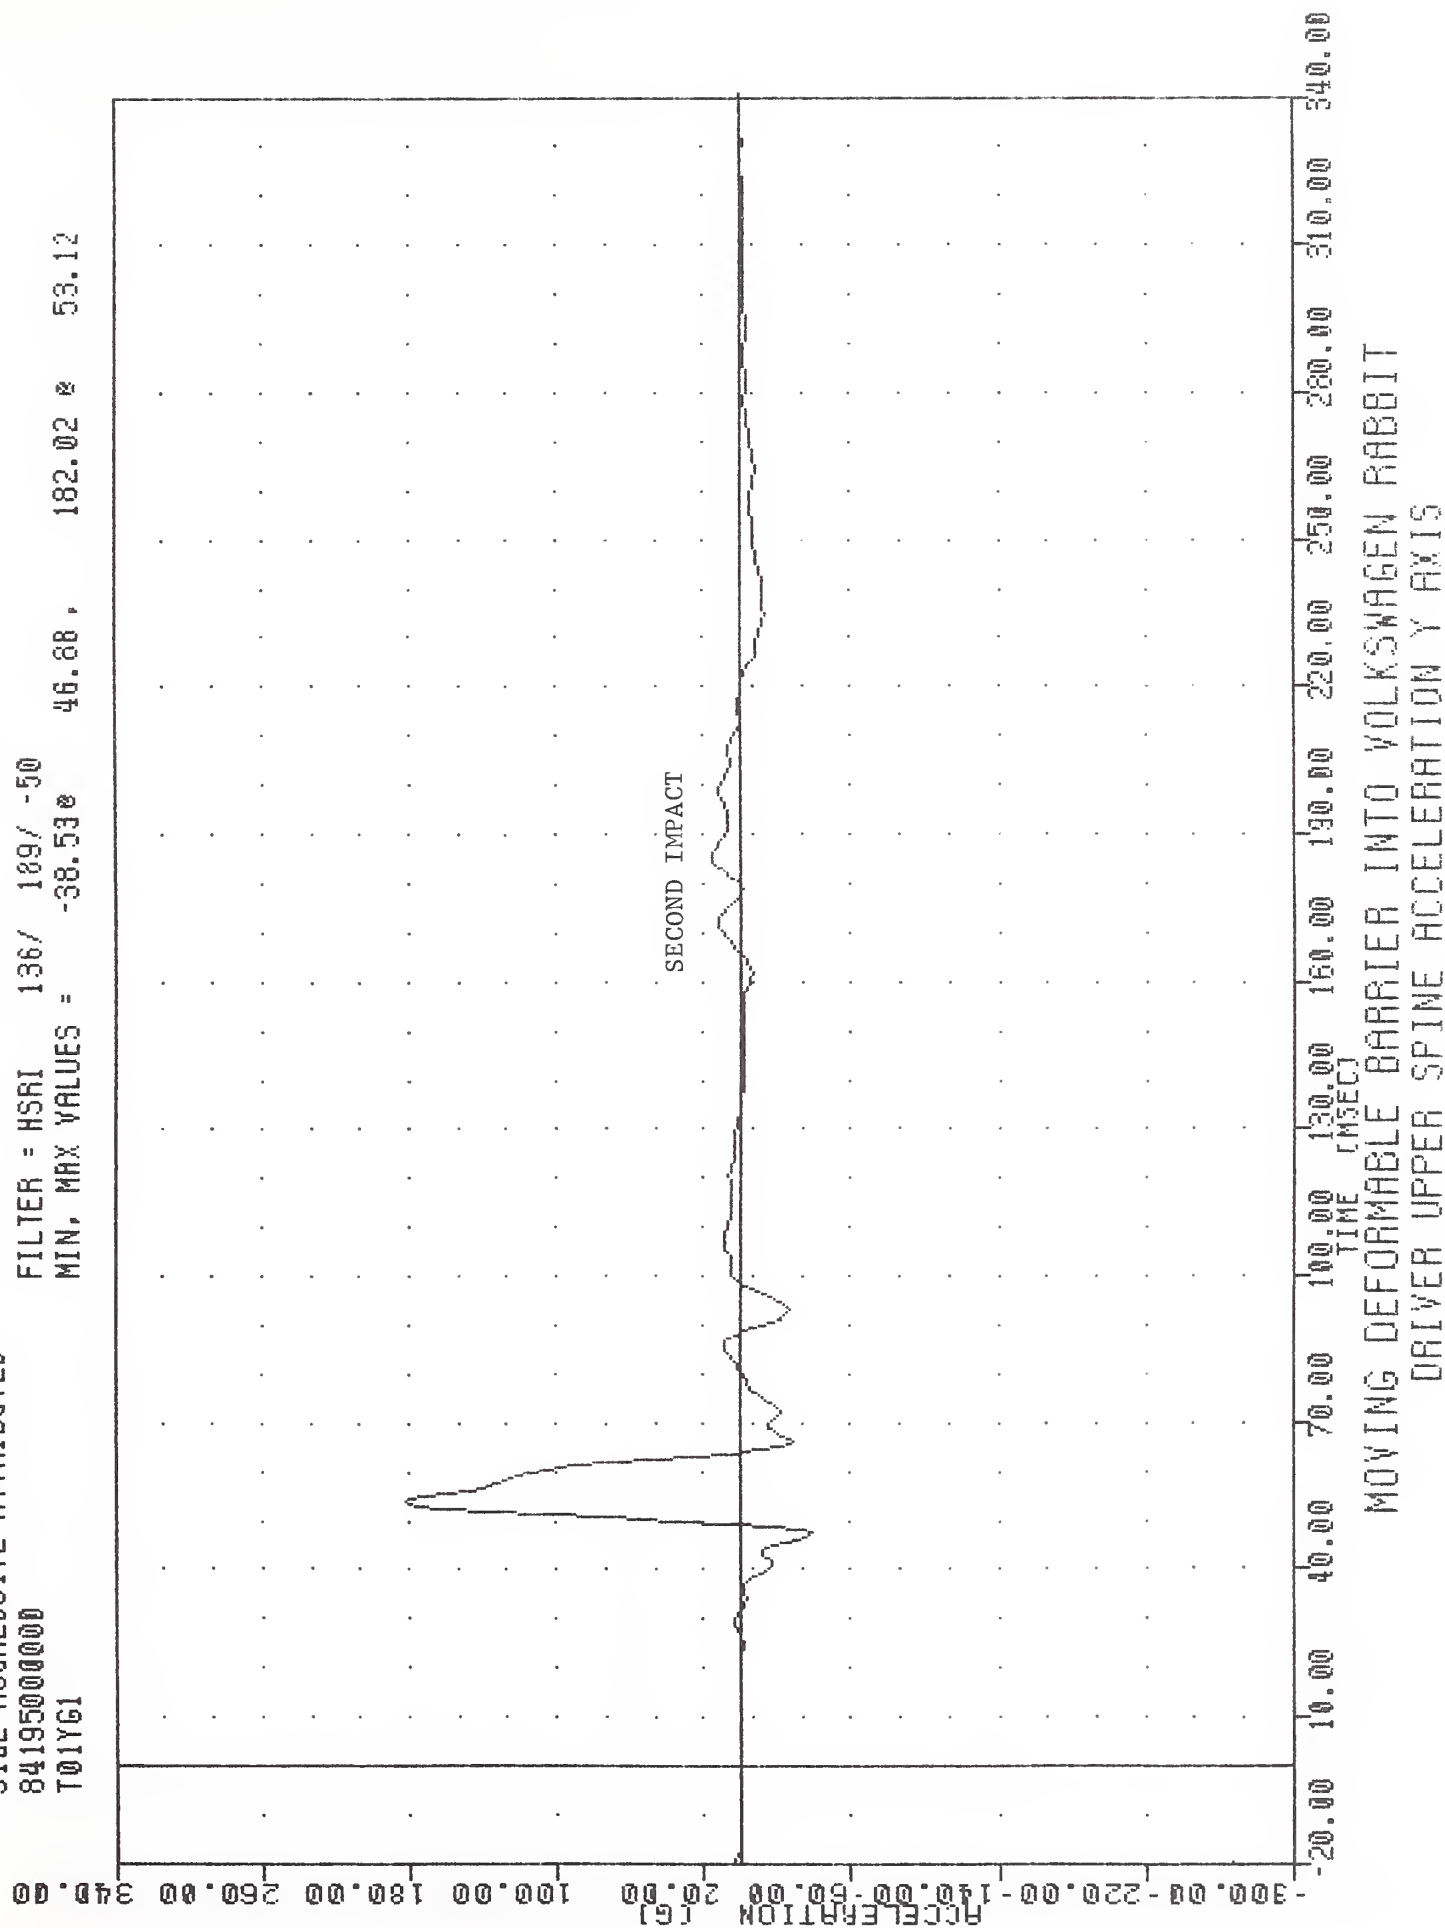
MOVING DEFORMABLE BARRIER INTO VOLKSWAGEN RABBIT
 DRIVER UPPER SPINE ACCELERATION Y AXIS

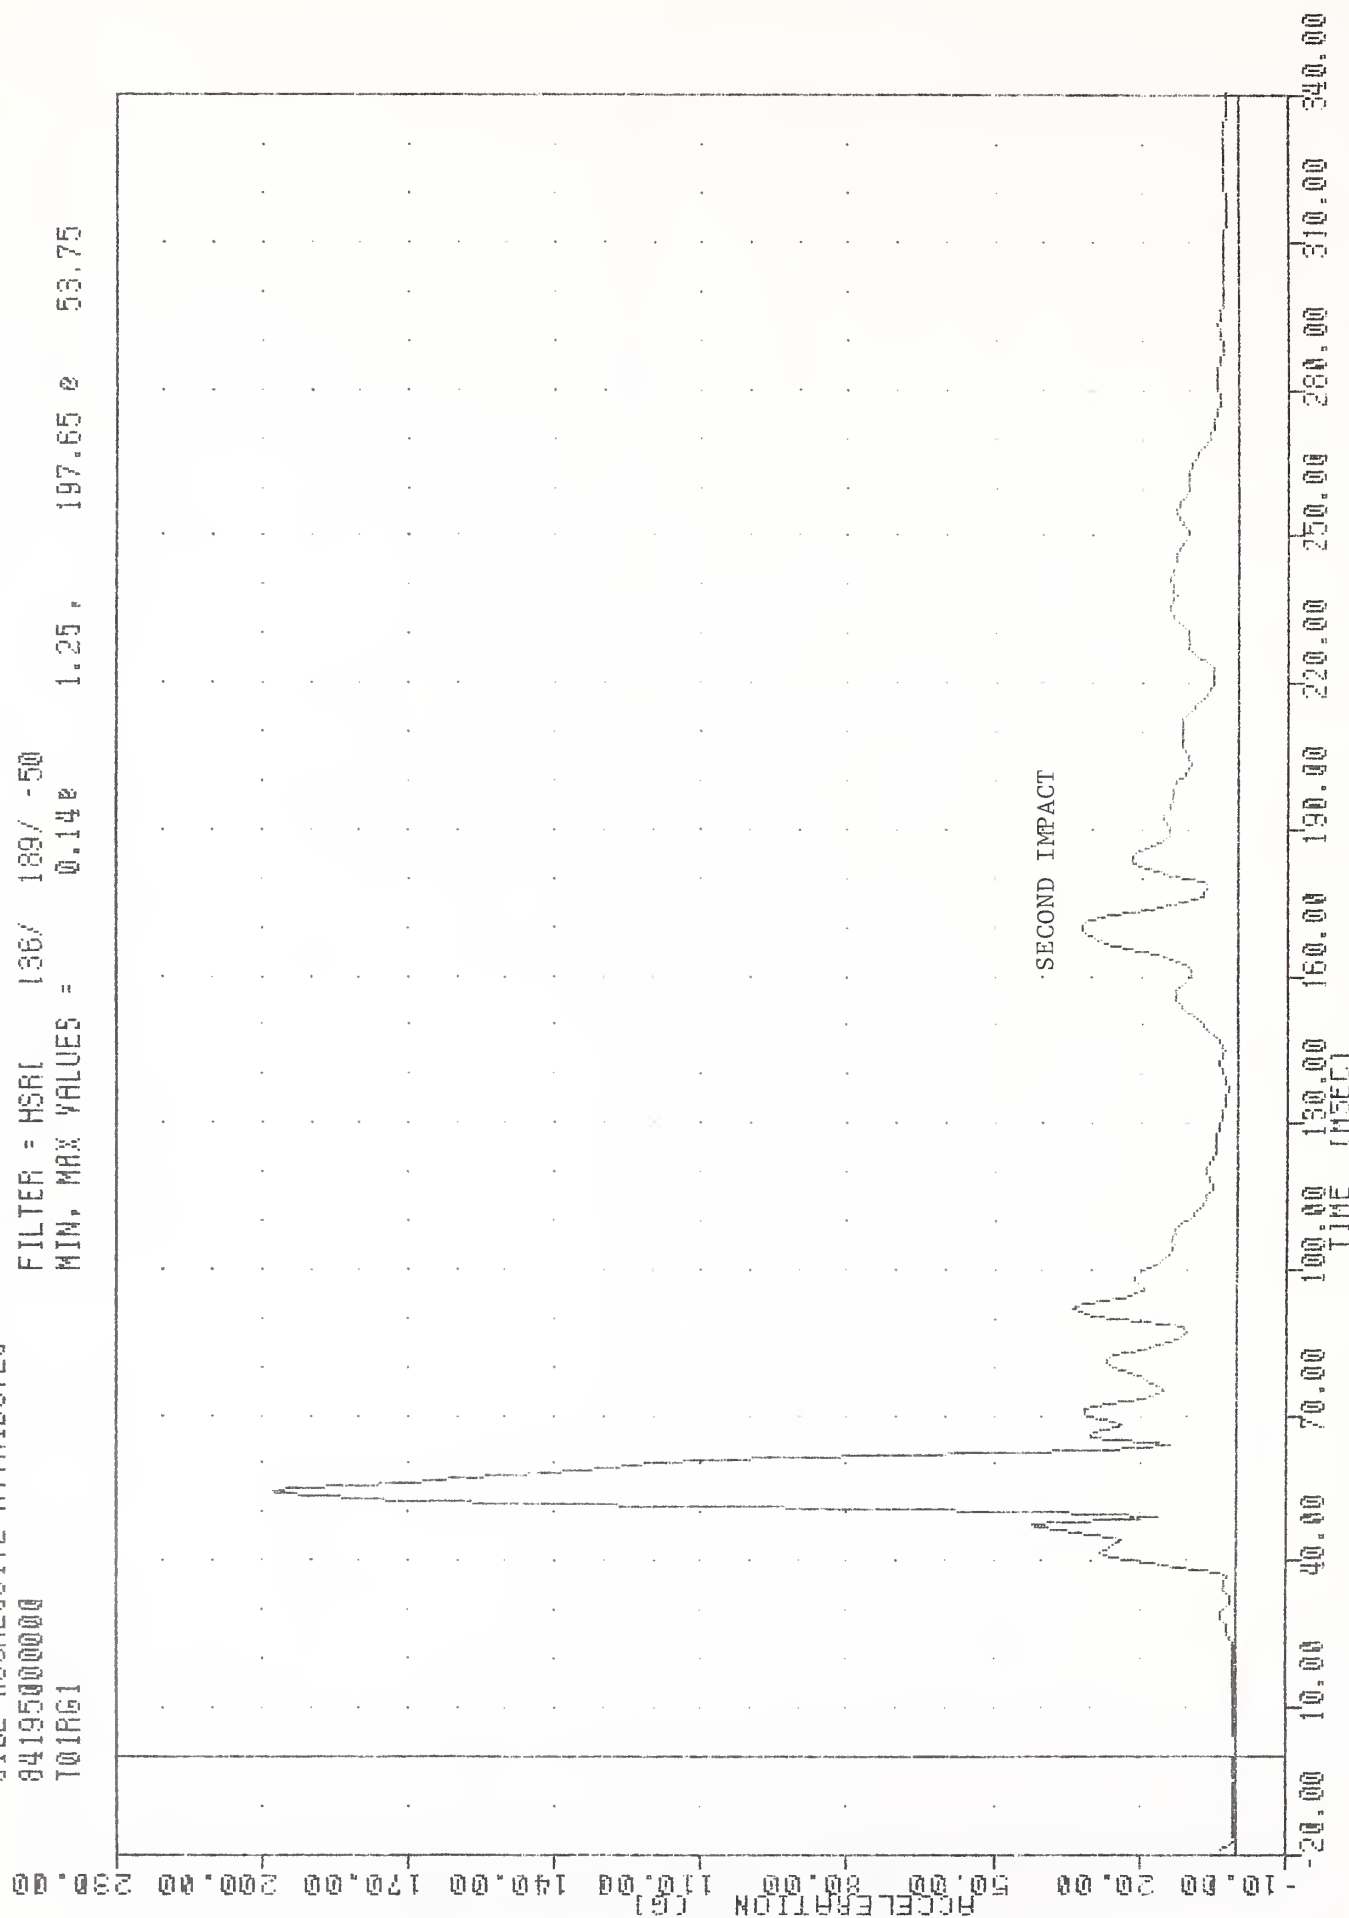
MOVING DEFORMABLE BARRIER INTO VOLKSWAGEN RABBIT
DRIVER UPPER SPINE RESULTANT

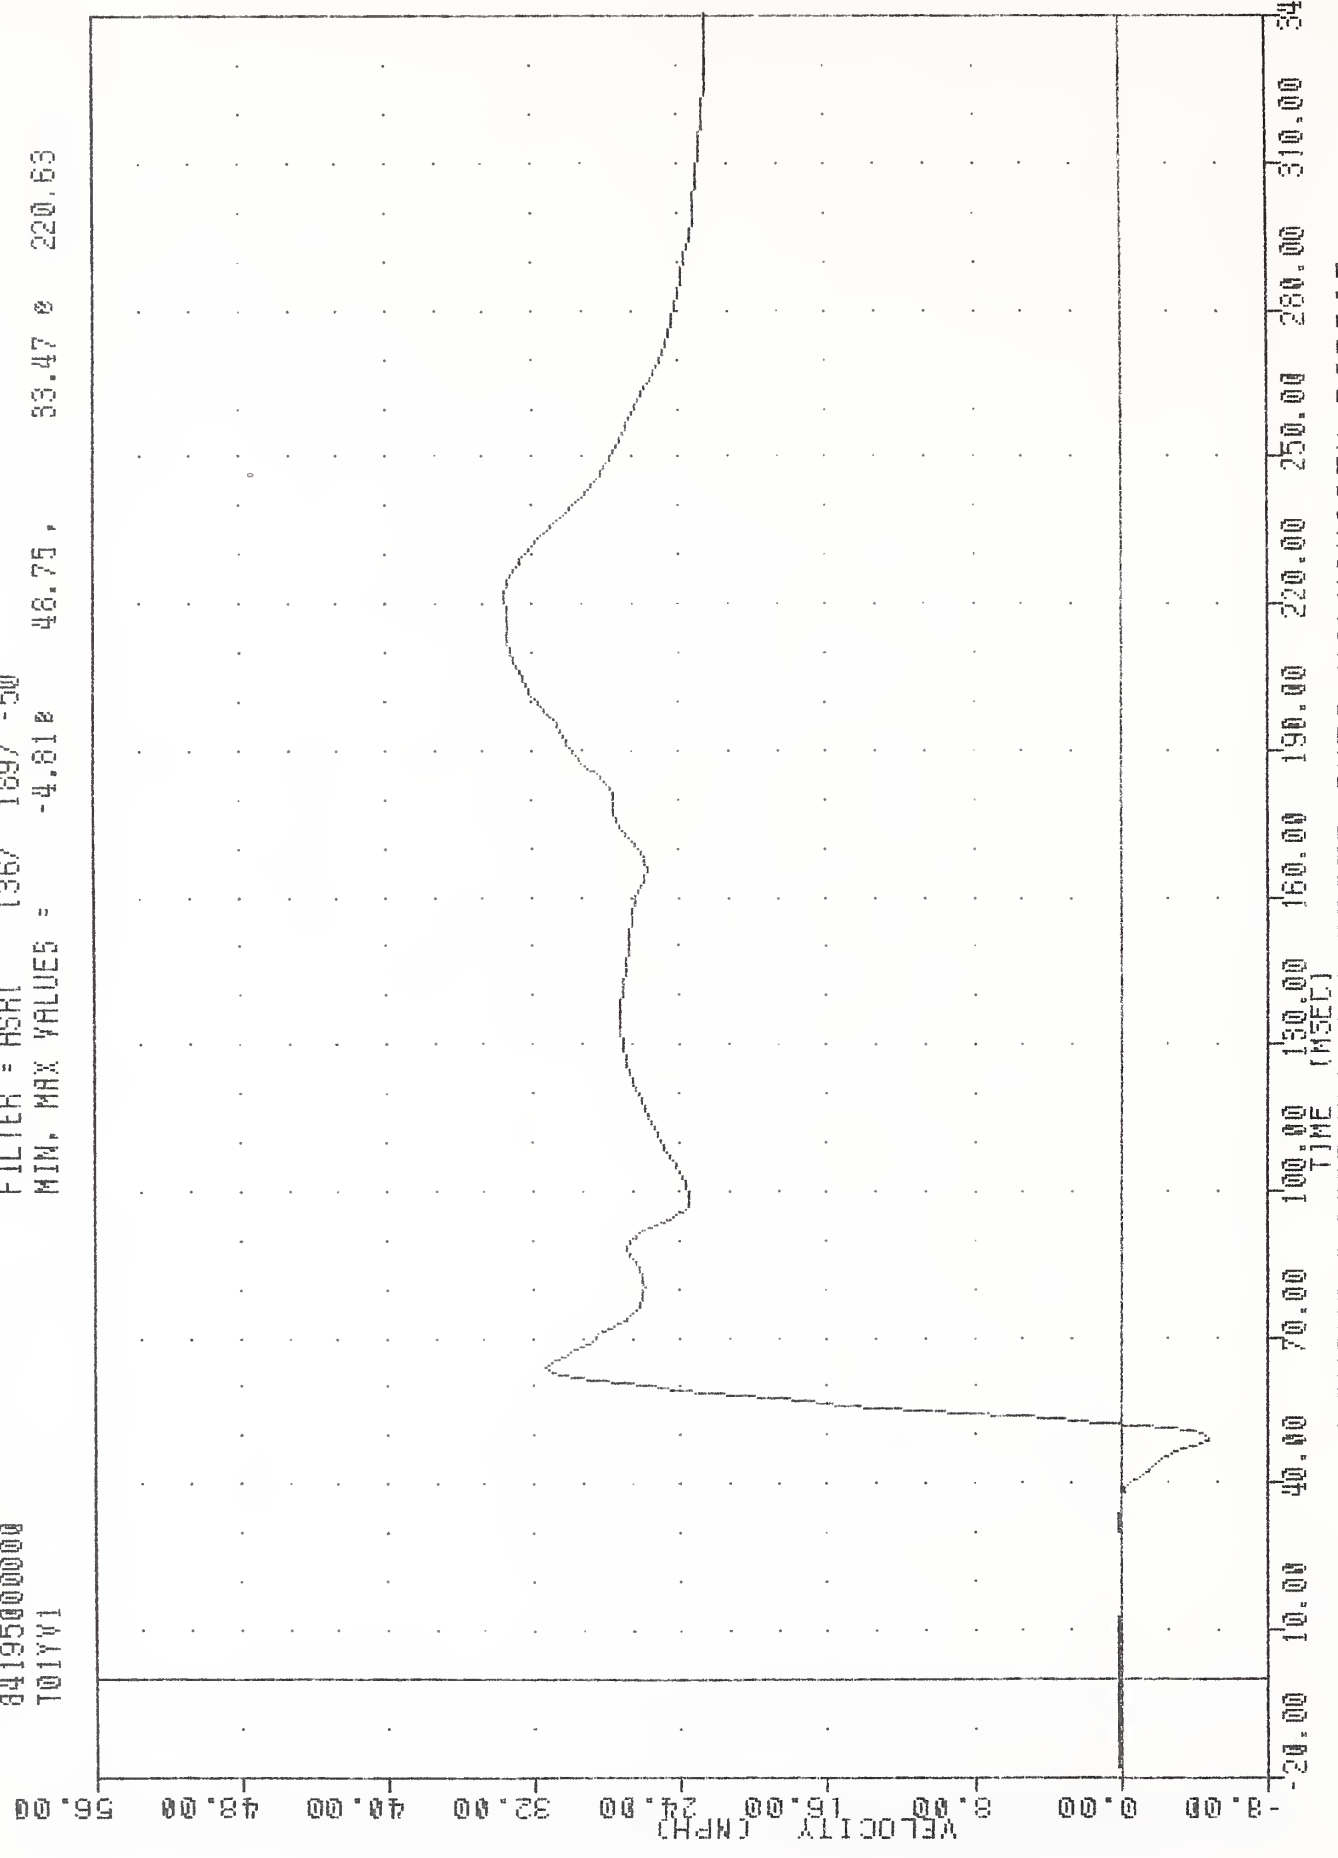
MOVING DEFORMABLE BARRIER INTO VOLKSWAGEN RABBIT
DELTA V USING T01YV1

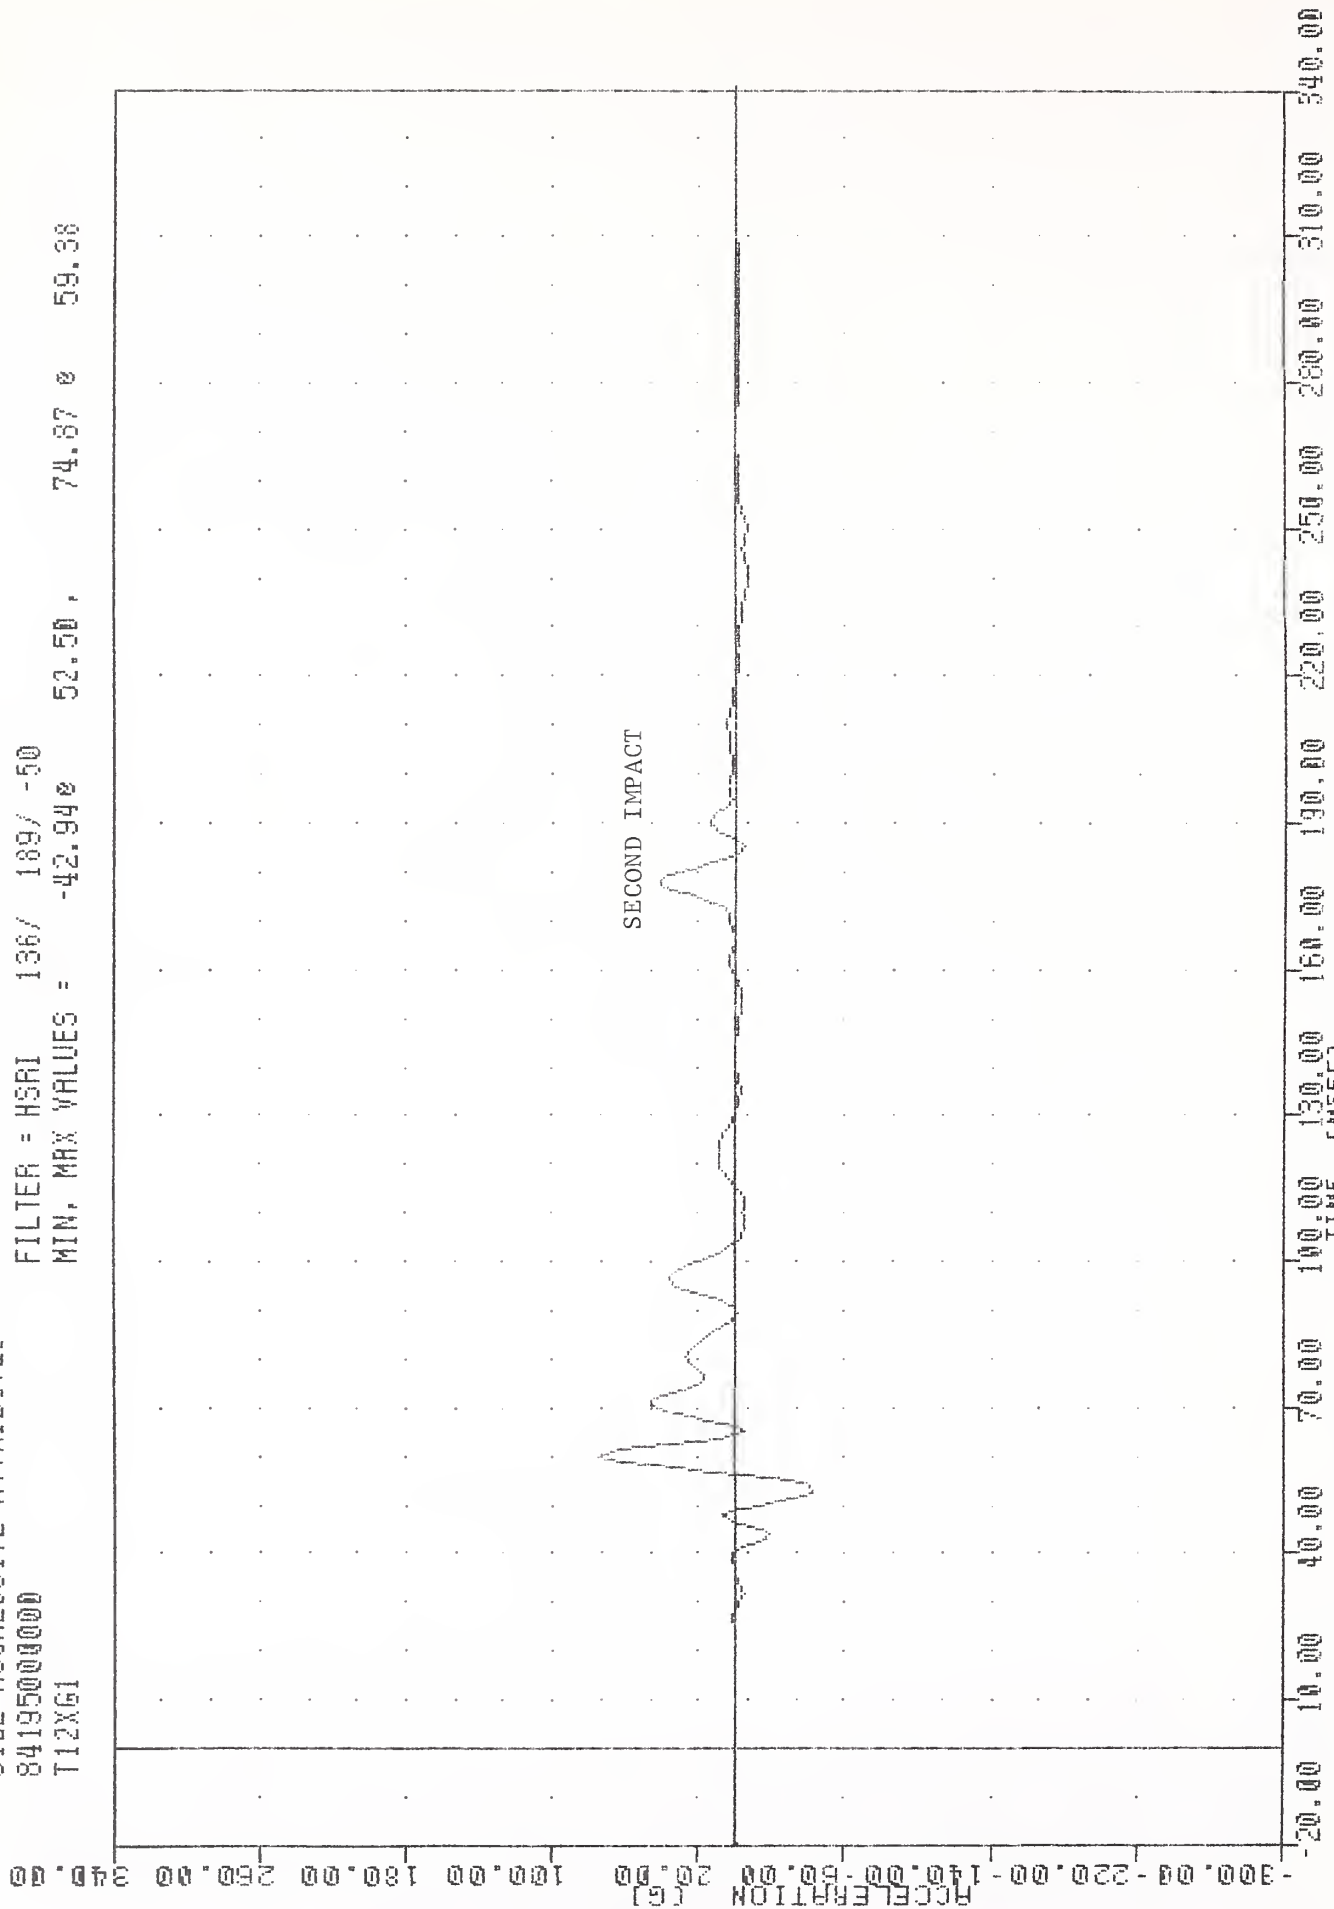
MOVING DEFORMABLE BARRIER INTO VOLKSWAGEN RABBIT
 DRIVER LOWER SPINE ACCELERATION X AXIS

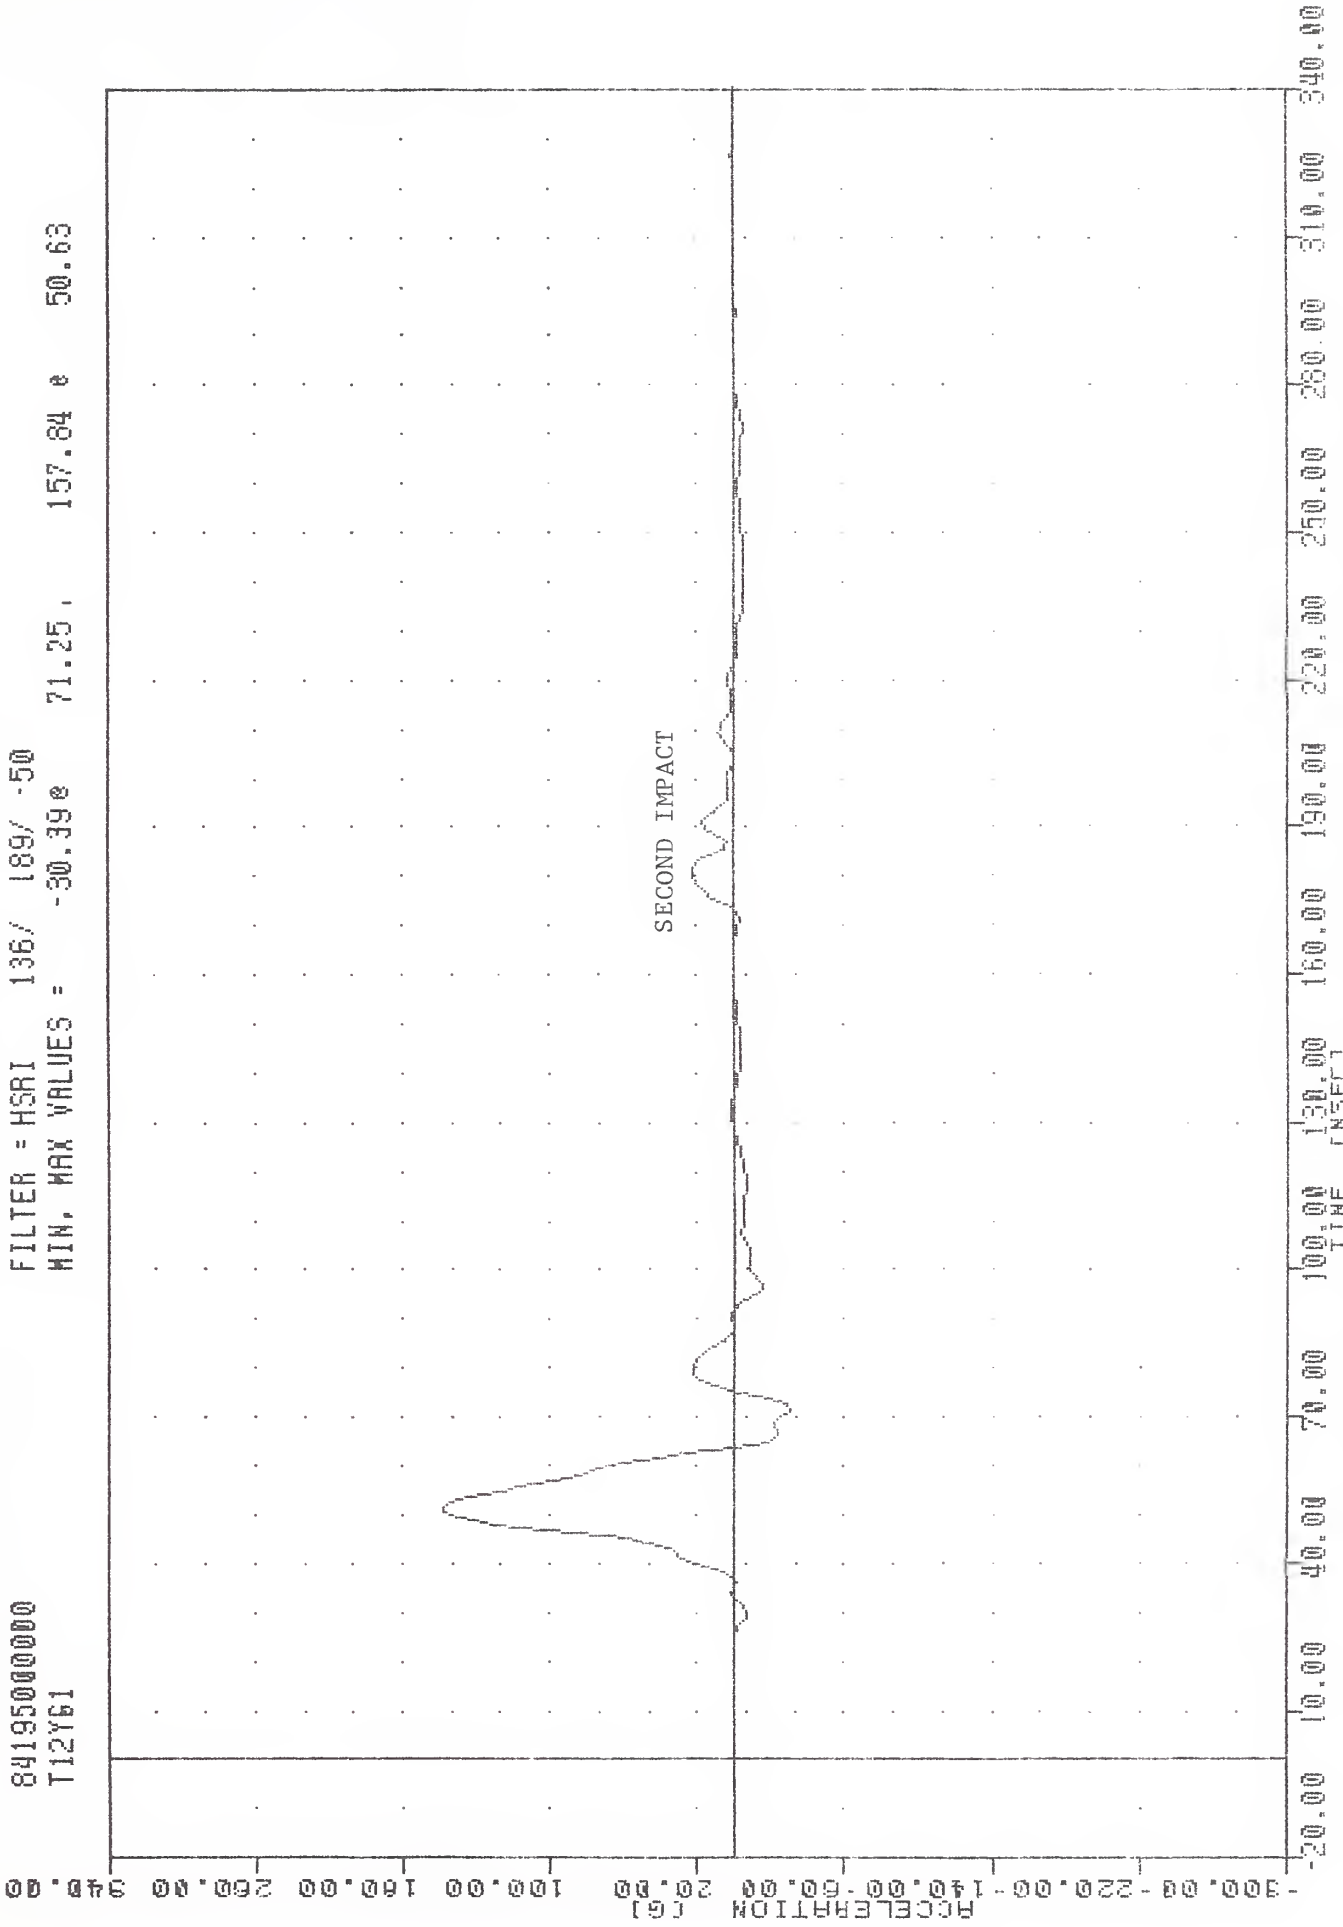
MOVING DEFORMABLE BARRIER INTO VOLKSWAGEN RABBIT
 DRIVER LOWER SPINE ACCELERATION Y AXIS

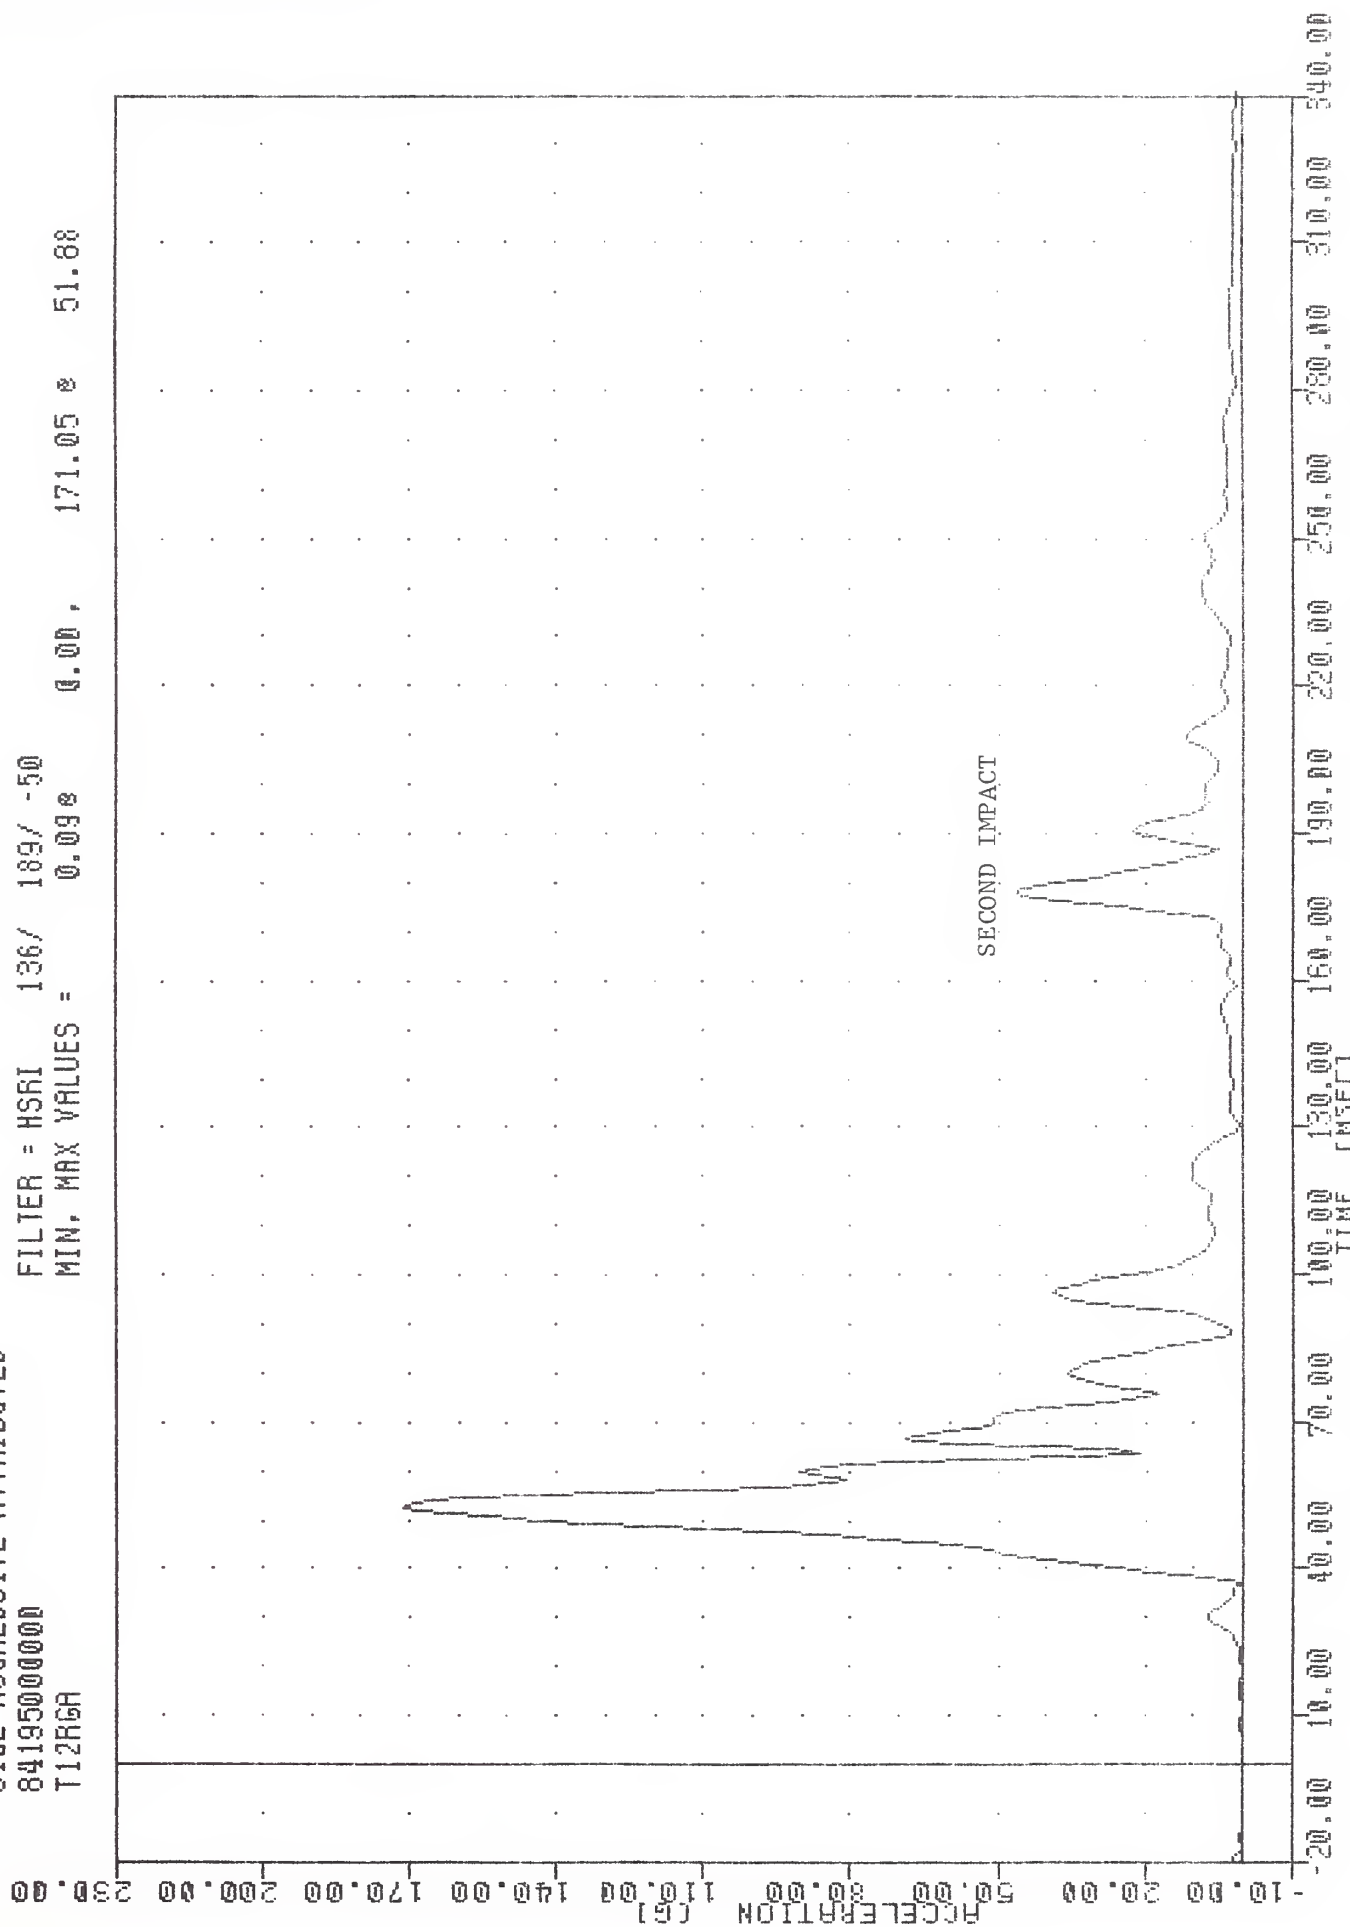
MOVING DEFORMABLE BARRIER INTO VOLKSWAGEN RABBIT
DRIVER LOWER SPINE RESULTANT USING T12Y6A

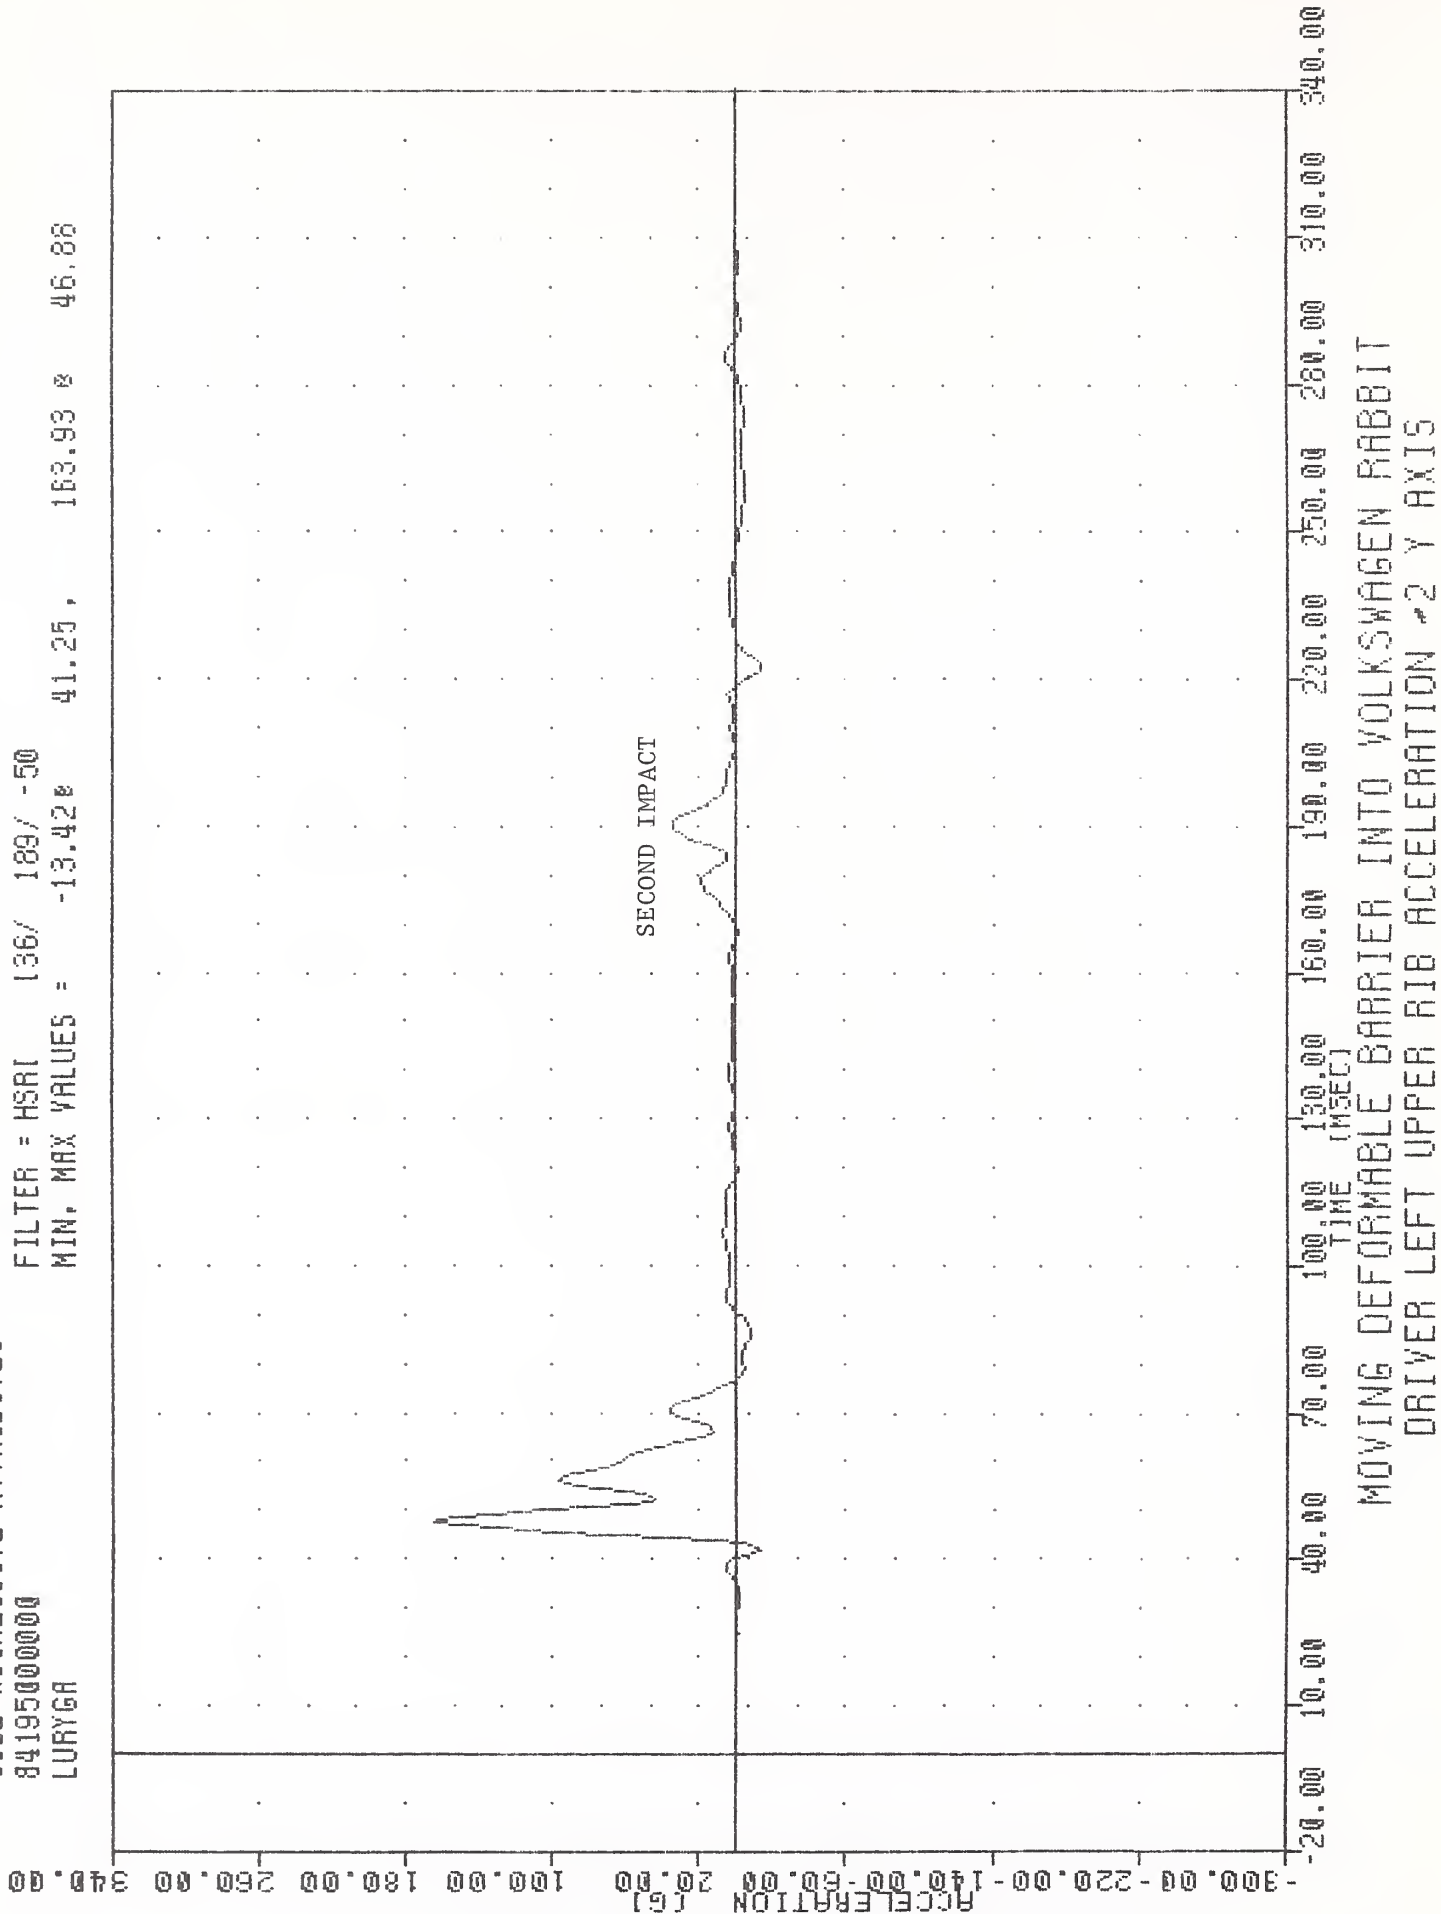
MOVING DEFORMABLE BARRIER INTO VOLKSWAGEN RABBIT
 DRIVER LEFT UPPER RIB ACCELERATION #2 Y AXIS
